Albany County Rail Trail Over New Scotland Road
Project Reference 18-C541
Colliers Engineering & Design Project No. 23010308P

Colliers Engineering & Design was requested by Albany County to perform the following investigative tasks in conjunction with the recent failure of the rail trail bridge over New Scotland Road:

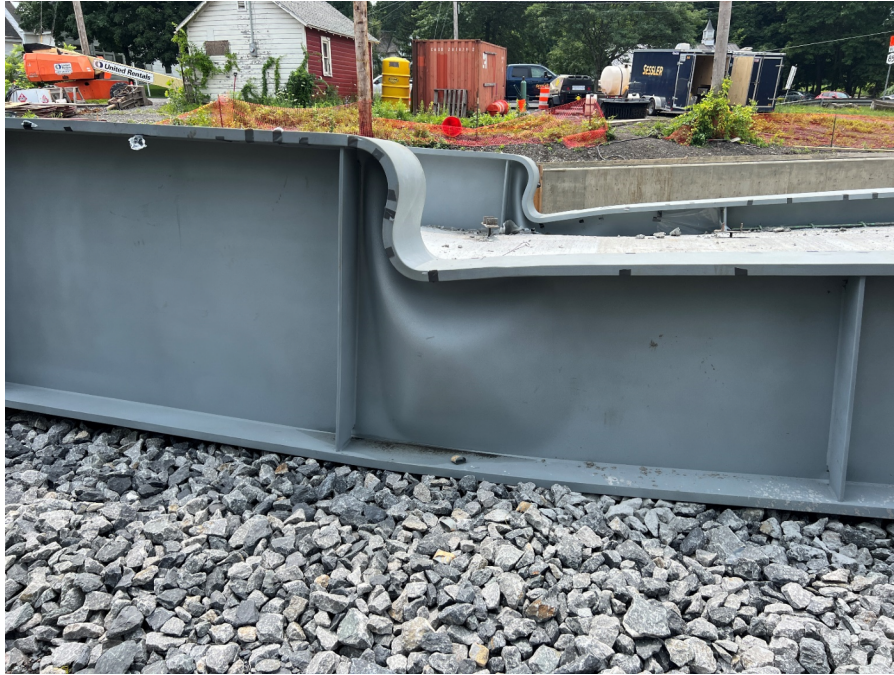
- **Photograph 1:** Severe web buckling, top flange distortion and permanent girder deflection was noted on both through girders at the location of the girder depth transition. Web buckling occurred over a length of approximately 52" and is full height of the web.

The failure of the bridge appears to have originated in the webs of the girders at the location of the top flange transitions. The girder webs at this location appear to have buckled under the loading of the deck placement causing the girders to “hinge” and collapse in on themselves at this location and then deflect downward until resting on the retaining walls below.

The top compression flange at the step transition locations was detailed in the contract plans to run from horizontal to vertical and back to horizontal. Typically, these types of girder depth transitions are done gradually over a longer length with a haunch or “fish belly” configuration. The abrupt compression flange transition in the step pattern at the bridge can result in a concentration of stresses being imparted into the web at the location of the transition. This often requires a detailed analysis along with providing additional strengthening of the girder web – either through the placement of additional web stiffeners in the step area (e.g. radial, vertical or horizontal) and/or providing additional web thickness. It does not appear this additional stress concentration in the webs at the transition locations were considered. As the web and vertical stiffeners are consistent across the entire length of the girder, it does not appear that the design accounted for this additional stress concentration at the webs at the step location.

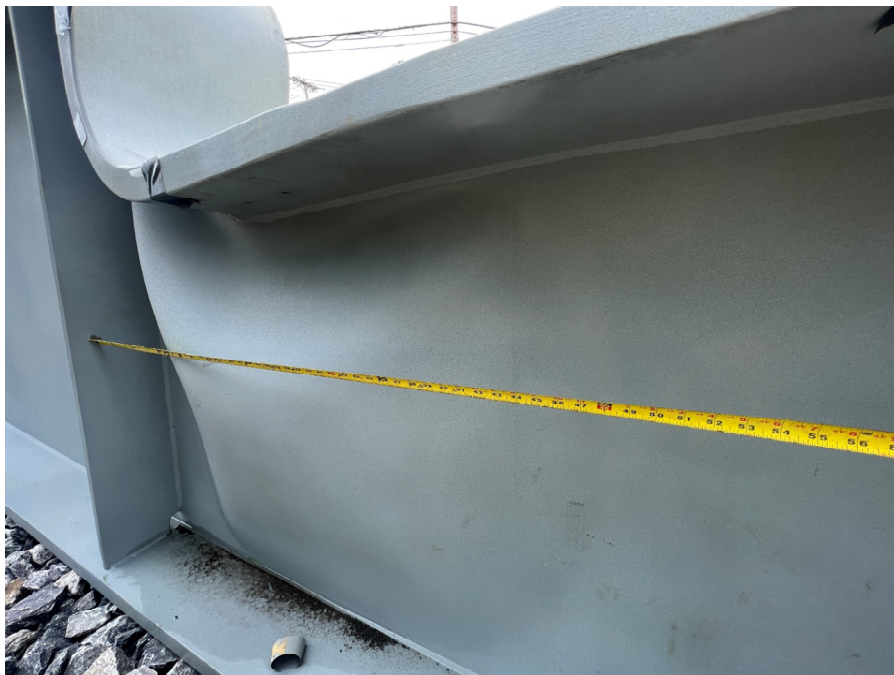
- **Photograph 2:** Lateral buckling of the web and top flange distortion

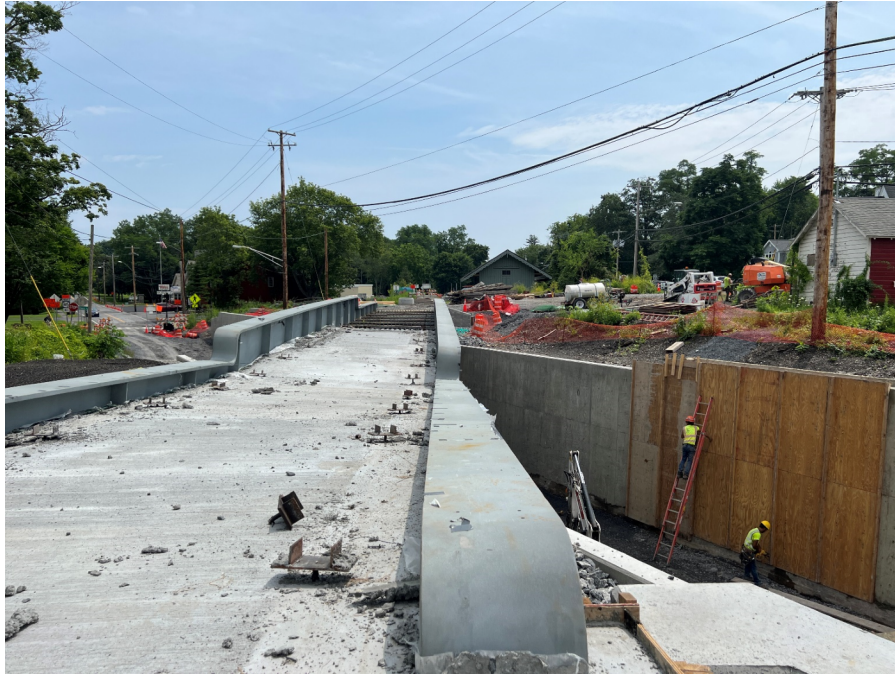
- **Photograph 3:** View along the bridge girder G2, slight lateral shift noted in the through girders. Concrete deck placement was progress to approximately midspan

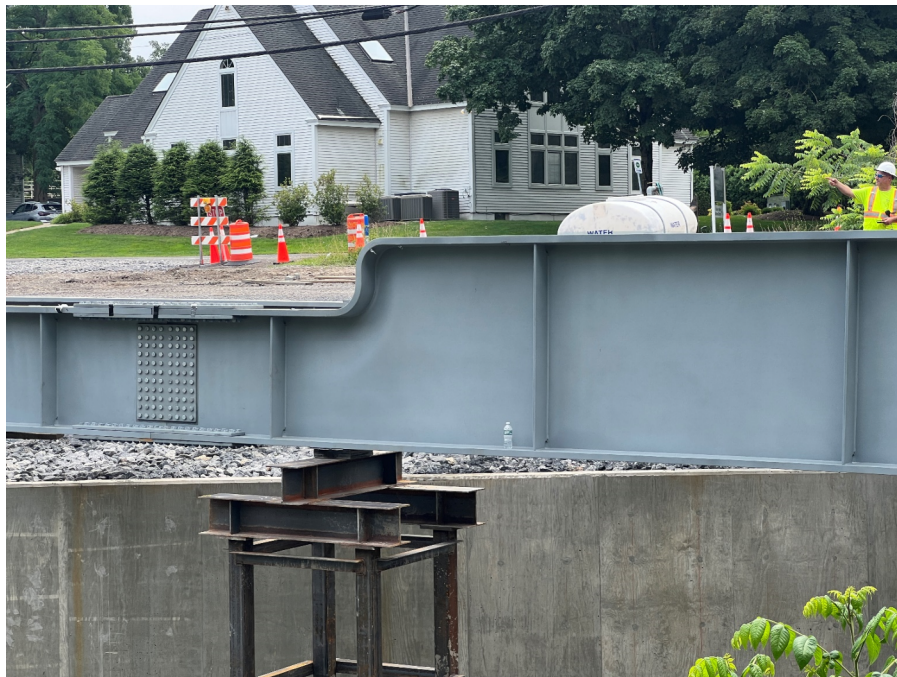
- **Photograph 4:** Web buckling also observed at Girder G1 near the "End" top flange transition. The "End" side of G1 was also showing signs of early buckling (G2 "End" did not show any signs).
